12 Manhattan Blvd.

Inspection Details

May 30, 2017

Inspection Summary

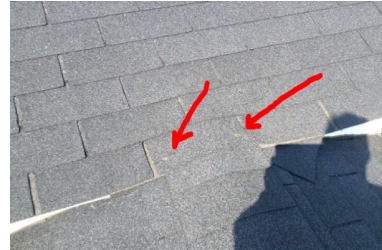
SLOPED (ROOF)

Level: 3rd floor, Location: North, Life expectancy: 7-10 yrs,
Estimated cost: high, Tar nailheads. In relatively good shape.
Monitor for signs of deterioration, Two plus layers noted,

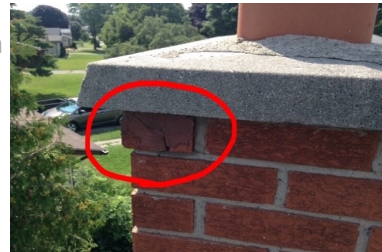
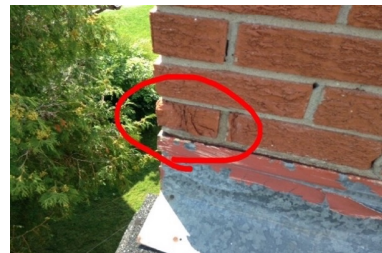
CHIMNEY

Location: South, Masonry with a clay flue, Minor deterioration
requires preventative maintenance,

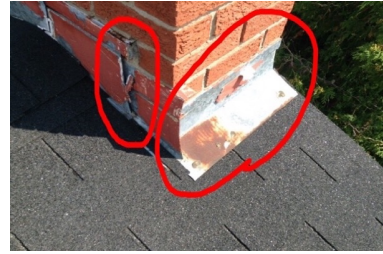
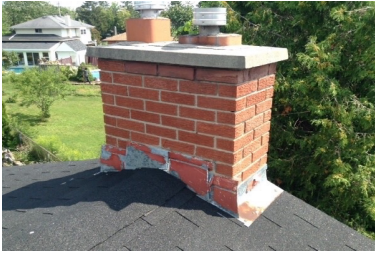
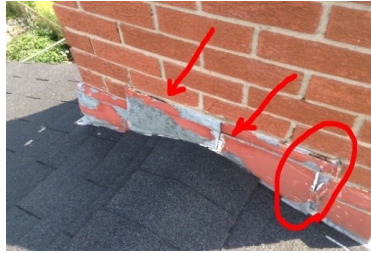
🚩 CHIMNEY (FLASHING)

Age: 15-20 yrs, Masonry, Caulking is cracked requiring maintenance, Metal is corroded and rusty, Repair to avoid leaking ,

Location: South, Masonry, Caulking is cracked requiring maintenance, Metal is corroded and rusty, Repair to avoid leaking , SUMMARY,

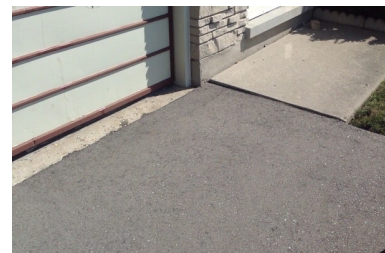
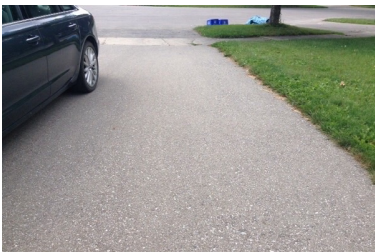
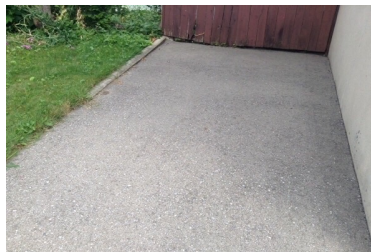
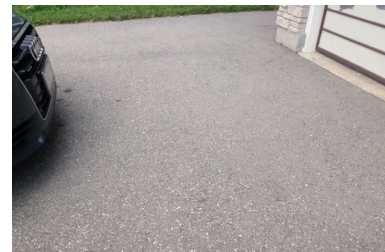
DRIVEWAY

Location: West, Asphalt, Normal aging, In good shape ,

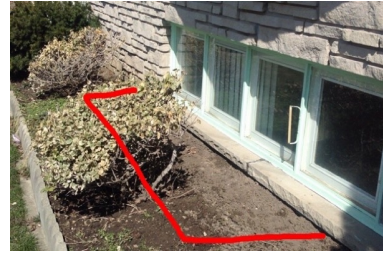
WINDOW WELLS

Level: basement, Location: West, Life expectancy: 2 years, Estimated cost: low, Generally flat, Missing well strongly recommended, Vulnerability to moisture spilling over foundation wall, Installation of well would be prudent,

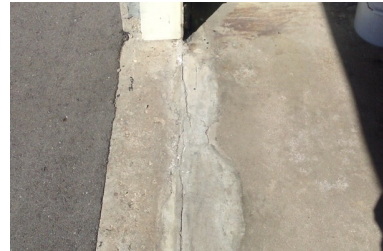
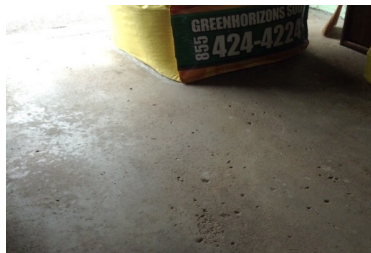
GARAGE

Location: North West, Concrete floor, Floor cracks are typical is size requiring little repair, Minor deterioration requiring preventative repairs,

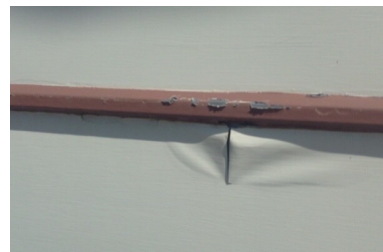
GARAGE DOOR

Location: North West, Estimated cost: very low, Metal, Paint needed, Evaluate further & repair,

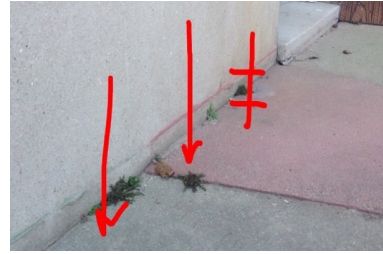
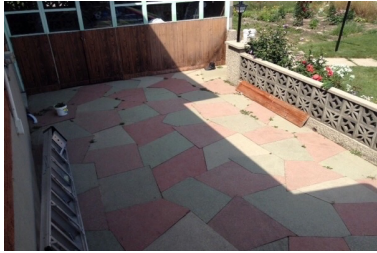
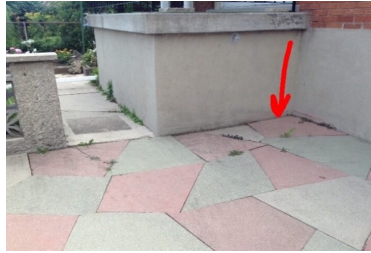
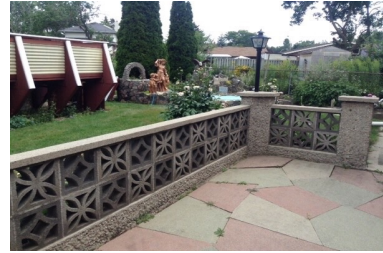
PATIO

Concrete, Minor settlement requiring minimal repairs,
Negative slope will strain building foundations with water,
Seal open gap at structure joint to redirect water, Evaluate
further & repair,

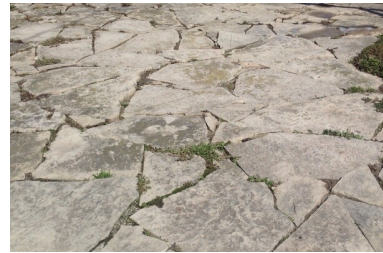
PATIO (2)

Location: North East, Stone, Minor settlement requiring
minimal repairs,

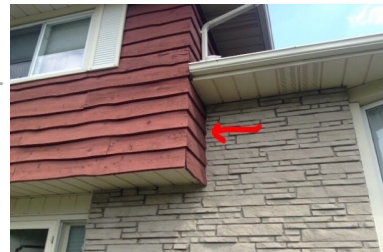
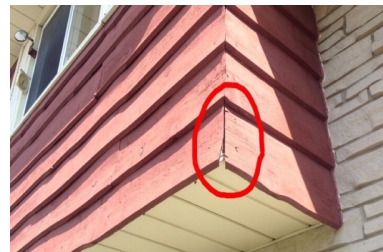
🚩 MAIN (WALLS)

Brick masonry, Wood siding, Stone masonry, Open building joints require caulking sealant, Minor deterioration needs common maintenance,

Location: throughout, Brick masonry, Wood siding, Stone
masonry, Open building joints require caulking sealant, Minor
deterioration needs common maintenance, SUMMARY,

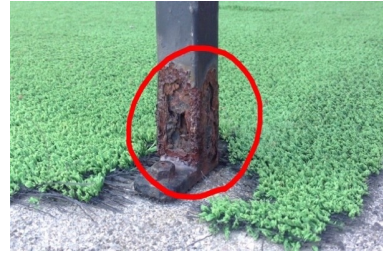
RAILINGS

Location: South East, Metal, Rot or deterioration require repairs,

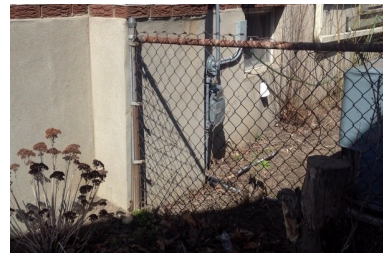
FENCES

Location: throughout, Metal, is corroded and rusty requiring eventual repairs,

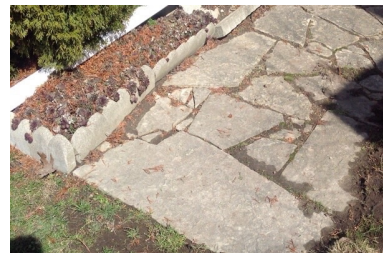
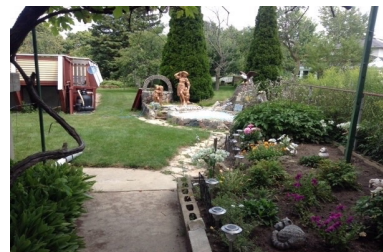
SIDEWALKS

Location: South, Stone, Minor settlement requiring minimal repairs, Evaluate further & repair,

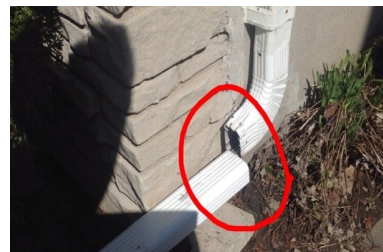
GUTTERS & DOWNSPOUTS

Location: throughout, Aluminum, Above grade gutter discharge, In relatively good shape with some minor damage, Discharge clearance needs improvement,

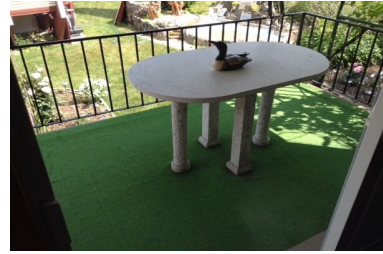
PORCH & DECK

Level: 2nd floor, Concrete, Generally in good shape,

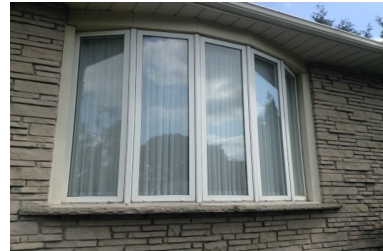
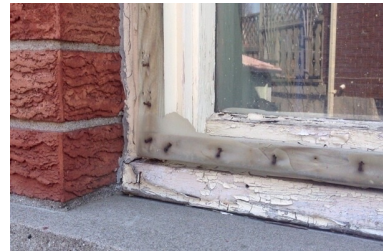
WINDOWS

Retrofitted with old wood frames clad over in metal, General maintenance / Repairs needed throughout, No general concerns,

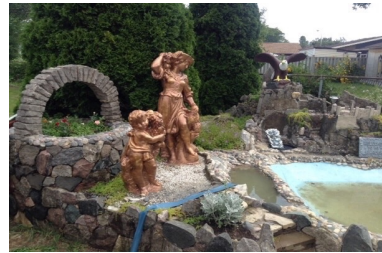
POOL (3)

Fountain Pond, Pump mechanics not thoroughly tested.
Vendor advised of a smooth operation with easy
winterization,

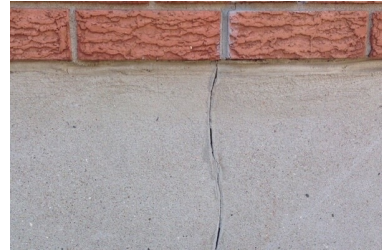
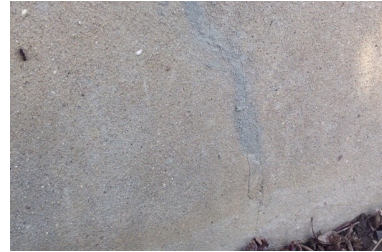
FOUNDATIONS OVERVIEW

Location: throughout, Poured concrete, In relatively good shape with some minor cracking, Monitor for any activity and repair as needed,

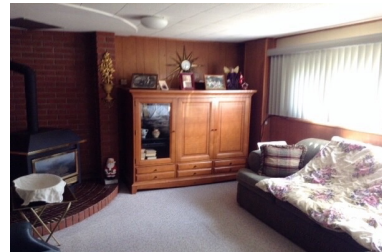
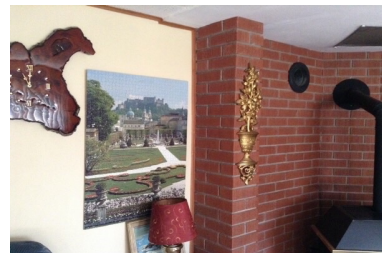
BASEMENT/ CRAWL SPACE

Concrete slab-on-grade, Finishes greatly hindered access to structure, No substantial signs of moisture noted during the inspection, What visible appears good,

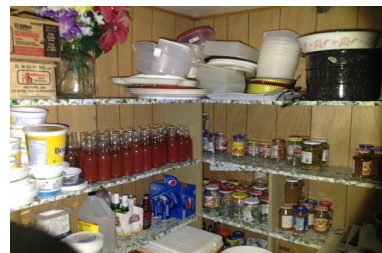
COLD CELLAR / CANTINA

Level: basement, Visibility: Excessive storage prevented access,

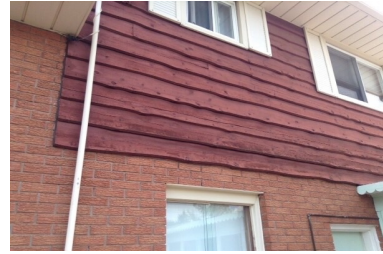
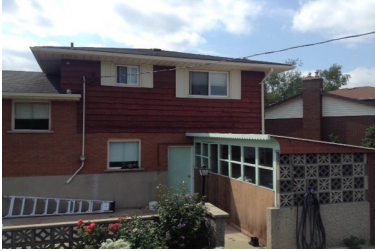
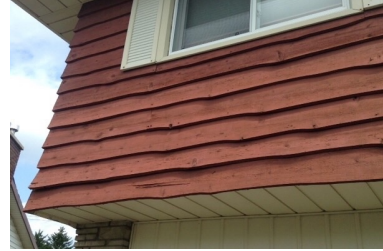
WALLS - OVERVIEW

Wood frame with Brick veneer, Wood frame with Siding,
Generally, in sound shape with some minimal repairs
needed,

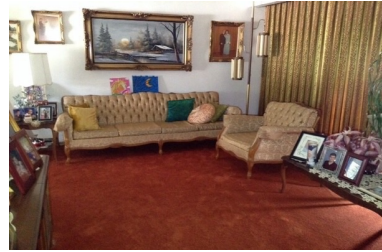
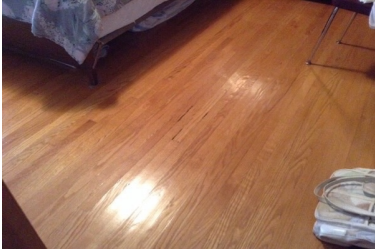
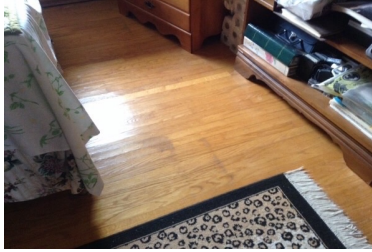
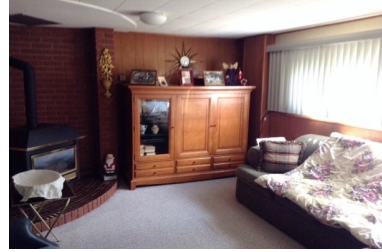
FLOORS

Hardwood, Ceramic tile, Carpet, All appear to waring normally,

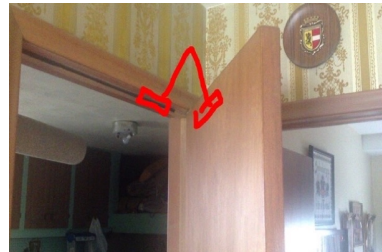
DOORS

Garage man door, Required automatic garage door closer is missing, Evaluate further and repair ,

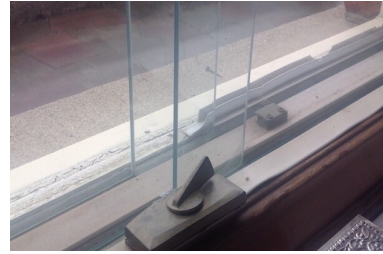
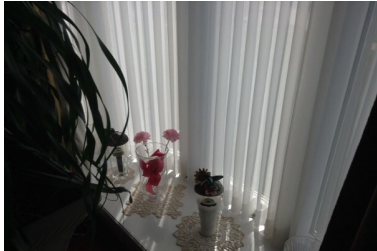
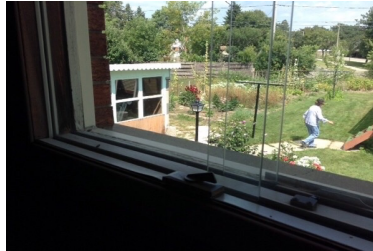
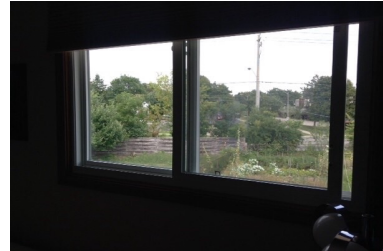
WINDOWS OVERVIEW

Vinyl, Casement, Sliding, Single glazed, Double glazed, Many have been updated, Consider replacement for the obsolete original windows,

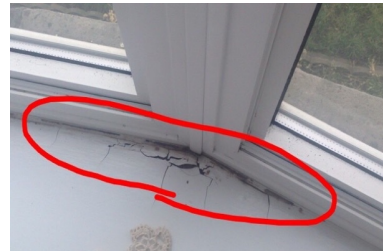
WINDOWS OVERVIEW (2)

Level: 2nd floor, Location: West, Wood, Minimal sill water damage requires repair. Ensure the actual problem is repaired,

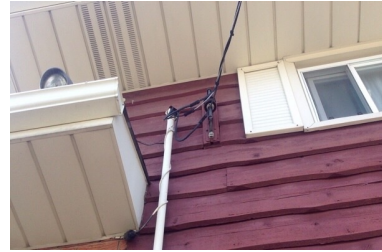
DELIVERY (MAIN)

Overhead with mast, Mast height is not to current standards, Drip loop is obsolete, Evaluate further & Improve, Only qualified contractors should conduct repairs,

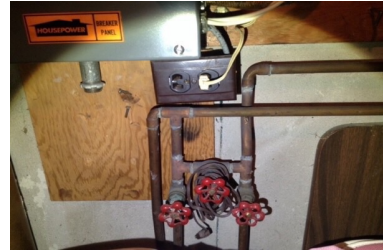
WATER SOURCE (SUPPLY)

Level: basement, Location: North East, Public - City municipal supply, Copper, In good shape,

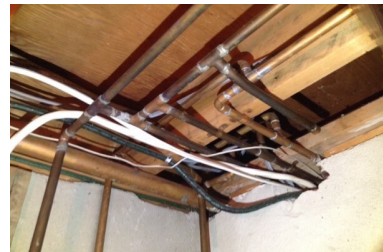
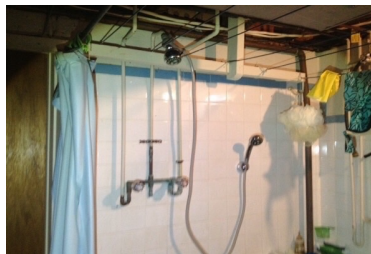
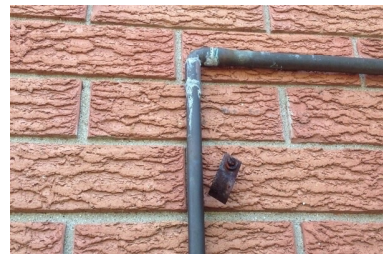
INTERIOR PIPING (SUPPLY)

Location: throughout, Copper, What accessible appeared to be in good working order, Ensure garden hose is winterized annually to avoid leaks,

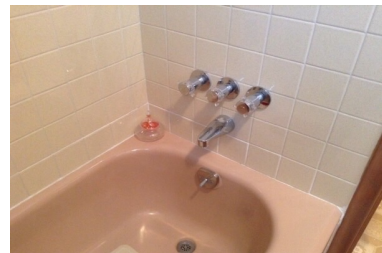
TUB (ENCLOSURE)

Level: 3rd floor, Location: East, Principle Main bathroom, Preventative maintenance will soon be required,

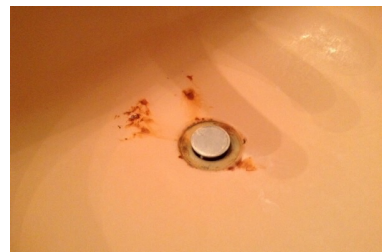
SINK (BASIN)

Bathroom #1, Rust & corrosion, Vanity base is damaged, Evaluate further & repair, Inaction will cause eventual water damage throughout,

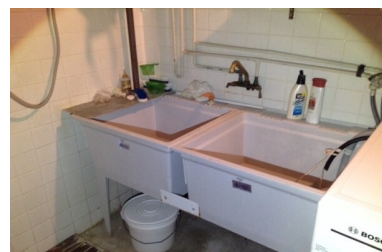
SINK (BASIN) (2)

Level: basement, Laundry, Updated nicely !,

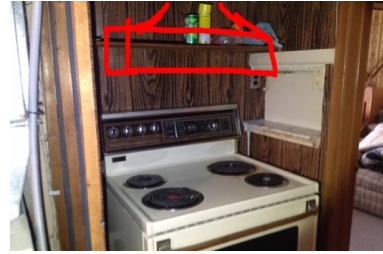
EXHAUST FAN(S)

Level: basement, Kitchen, Exhaust is missing and strongly recommended , Required in this location, Evaluate further & repair,

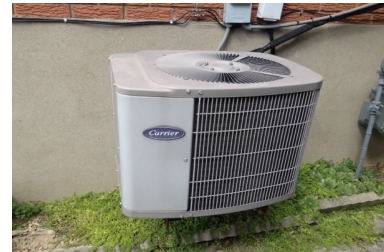
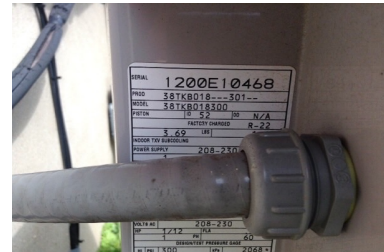
SYSTEM TYPE / SPECS

Age: 13 - 18 yrs, btu's: < 1.5 ton, Life expectancy: 16 - 20 yrs, Air Conditioner, On the older side, but still some life should exist, Appears to be in a reasonably good working condition, Mid life in terms of service with MEDIUM failure probability,

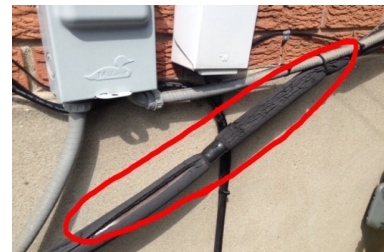
REFRIGERANT LINES

Cooling plant #1, Incomplete insulation reduces efficiency, Evaluate further & repair,

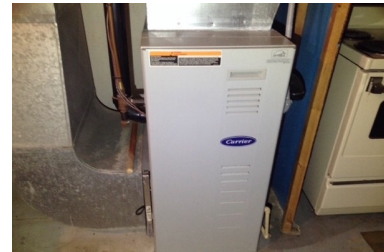
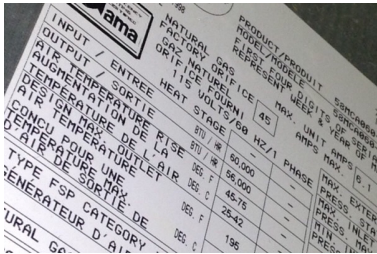
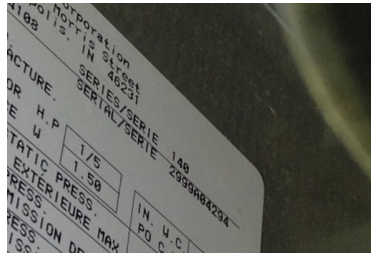
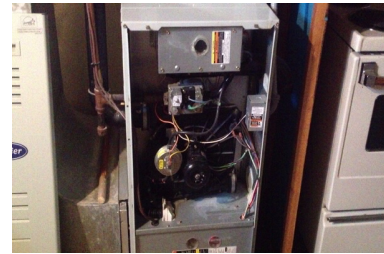
🚩 SYSTEM TYPE / SPECS

Age: 15-20 yrs, Forced air furnace, High-Efficiency, Nearing the end of its natural life expectancy, Old in terms of service with HIGH failure probability,

Age: 15-20 yrs, btu's: 50-60000 btu, Life expectancy: 20 yrs, Forced air furnace, High-Efficiency, Nearing the end of its natural life expectancy, Old in terms of service with HIGH failure probability, SUMMARY,

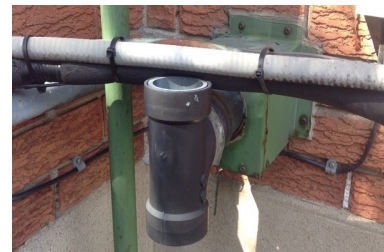
EXHAUST FLUE / LINER

Level: 1st floor, Location: South West, Life expectancy: 1 year, Powered vent induced draft motor, Inadequate clearance from combustibles, Evaluate further and repair,

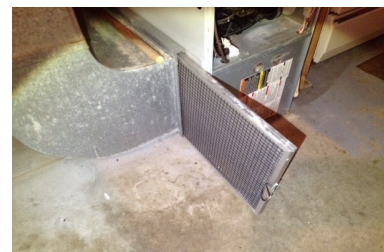
AIR FILTER

Fiber filter, Clean / service quarterly,

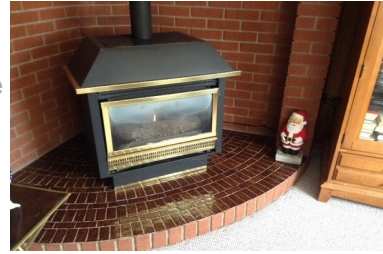
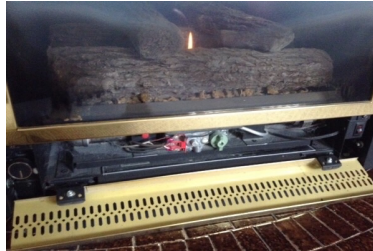
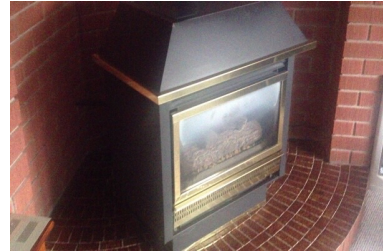
FIREPLACE & STOVE

Level: basement, Location: South East, Gas, Normal wear /
Appears to be operating well, Excessive carbon on protective
glazing, requiring cleaning,
