12 Manhattan Blvd.

Inspection Details

May 30, 2017

Inspection Summary

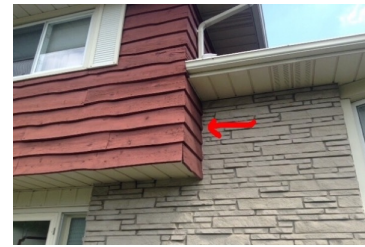
EXTERIOR - MAIN (WALLS)

Brick masonry, Wood siding, Stone masonry, Open building joints require caulking sealant, Minor deterioration needs common maintenance,

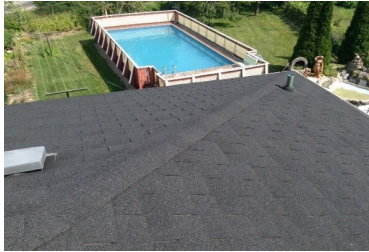
SLOPED (ROOF)

Level: 3rd floor, Location: North, Life expectancy: 7-10 yrs,
Estimated cost: high, Tar nailheads. In relatively good shape.
Monitor for signs of deterioration, Two plus layers noted,

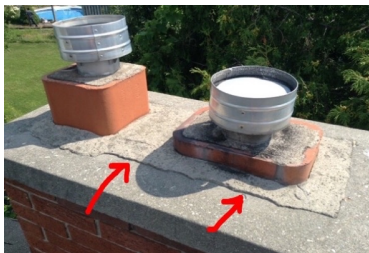
CHIMNEY

Location: South, Masonry with a clay flue, Minor deterioration
requires preventative maintenance,

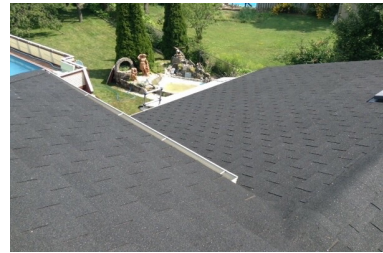
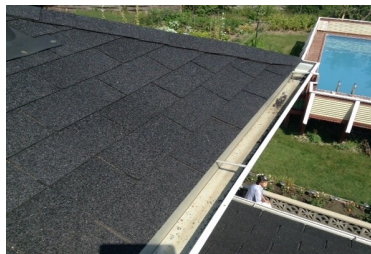
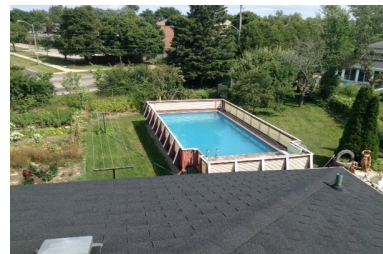
SLOPED (ROOF) (2)

Level: 2nd floor, Location: South, Life expectancy: 5 years, Asphalt shingles,

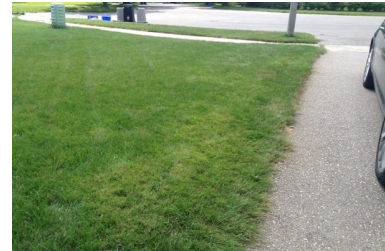
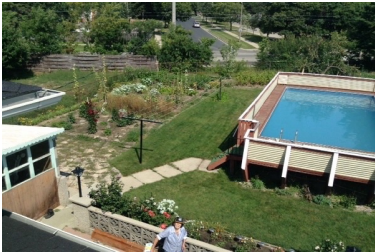
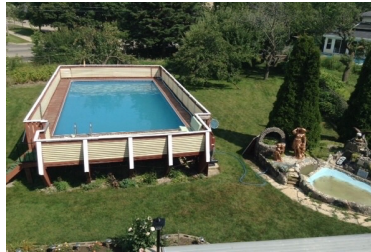
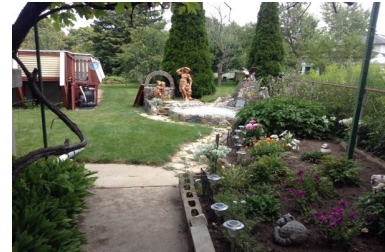
LOT GRADING

Location: throughout, Generally flat, Always ensure proper drainage away from structure , Generally in good shape,

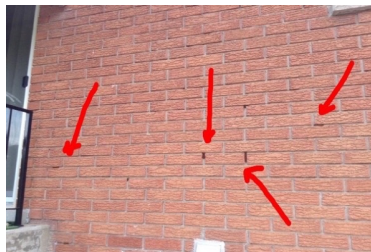
🚩 MAIN (WALLS)

Location: throughout, Brick masonry, Wood siding, Stone
masonry, Open building joints require caulking sealant, Minor
deterioration needs common maintenance, SUMMARY,

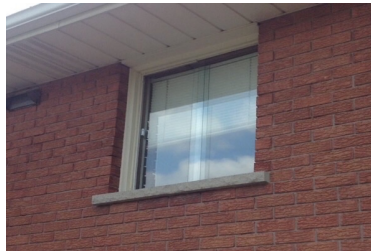
WINDOWS

Retrofitted with old wood frames clad over in metal, General maintenance / Repairs needed throughout, No general concerns,

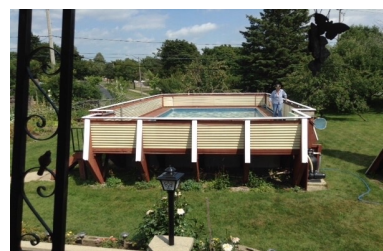
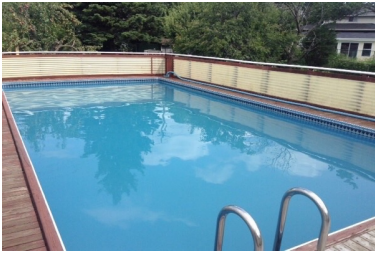
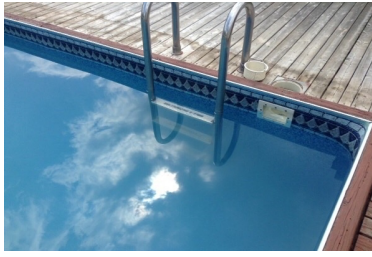
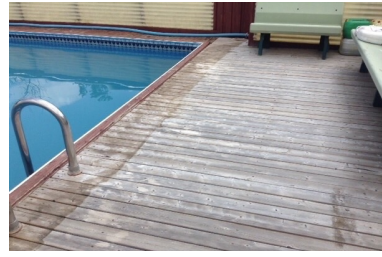
POOL

Above ground permanent (fixed), Not thoroughly inspected, Have a qualified contractor evaluate and service,

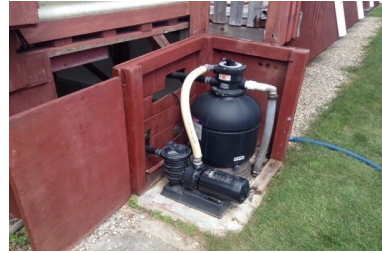
POOL (2)

Pump appears to be operating well. Service annually,

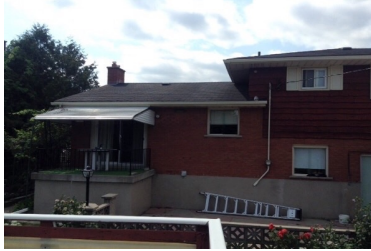
WALLS - OVERVIEW

Wood frame with Brick veneer, Wood frame with Siding,
Generally, in sound shape with some minimal repairs
needed,

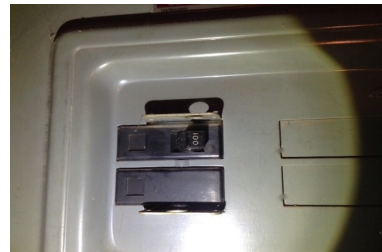
MAIN DISCONNECT (AMPS)

Level: basement, Location: North East, Amperes: 100 amps, Breaker (Main disconnect), In good operating order,

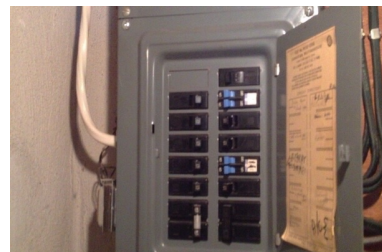
DISTRIBUTION PANEL

Level: basement, Location: North East, Breakers - Older panel, Panel upgrade would be prudent ,

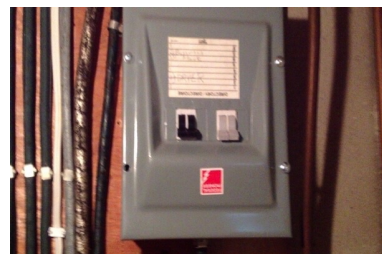
AUXILIARY PANEL

Breakers, Operating well ,

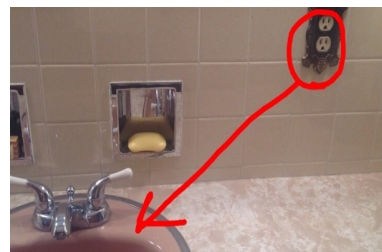
BRANCH WIRING

Location: throughout, COPPER wiring, What accessible appeared to be in good working order, Ground Fault Interruptors should be installed in washrooms and kitchen sink for safety,

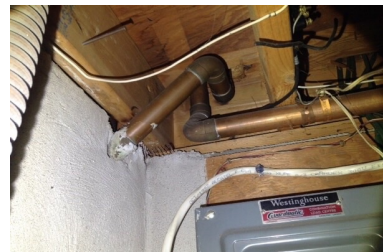
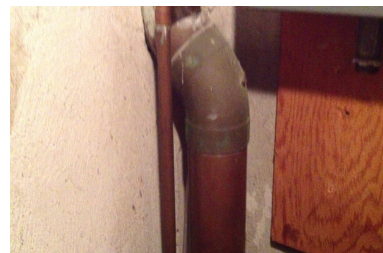
WASTE PIPING

Location: throughout, Copper, Plastic, What accessible appeared to be in good working order,

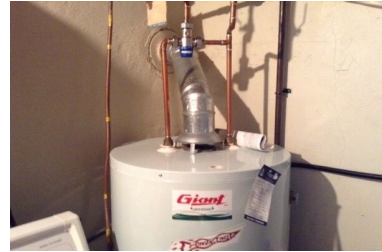
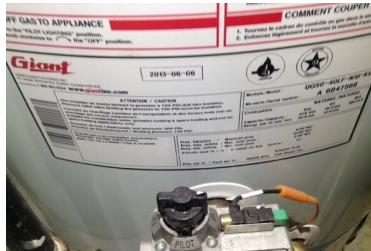
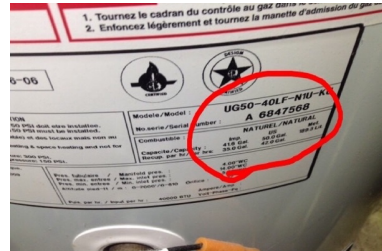
WATER HEATER TANK

Level: <5 years, Location: 40 gallons, Life expectancy: 12-15 yrs, Draft hood tank, Natural Gas, Appears to be operating well,
